Home Condition Survey

Property Address:	1, High St Bletchley MILTON KEYNES MK11AA
Report Reference Number:	322695
Date of Inspection:	14 May 2008

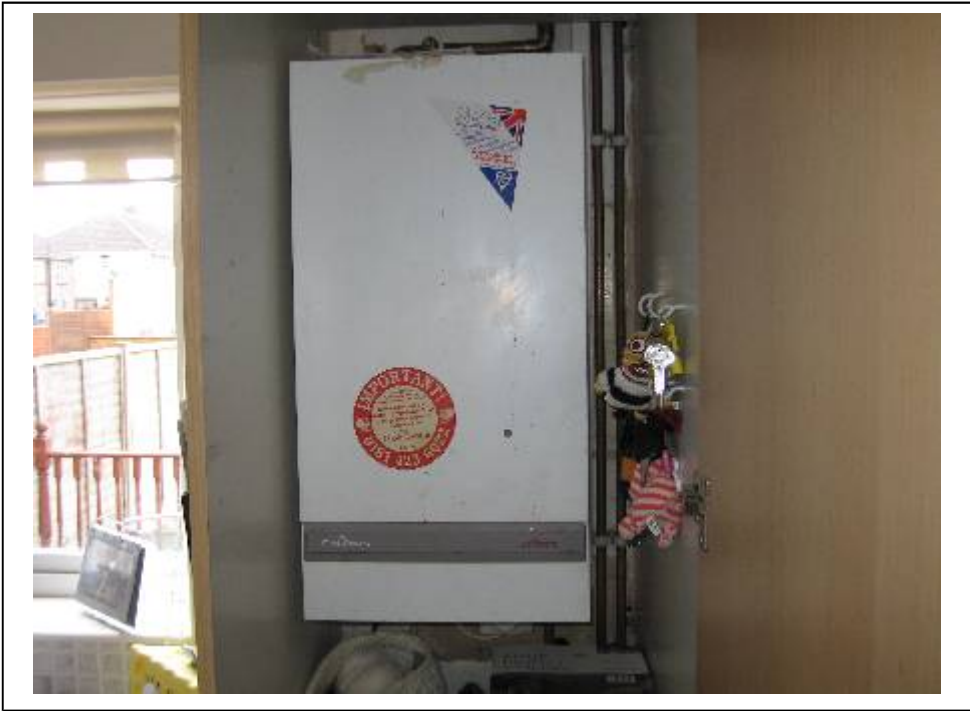
Boiler

F4. Heating	The heating and hot water is provided by a gas boiler which is located in the kitchen. The radiators are not fitted with thermostatic valves, which would provide improved control of the heating system. The central heating expansion tank in the roof void is in a satisfactory condition, but is not adequately insulated. No defects were noted. Some repairs or replacements are required but these are not considered serious or urgent.	2

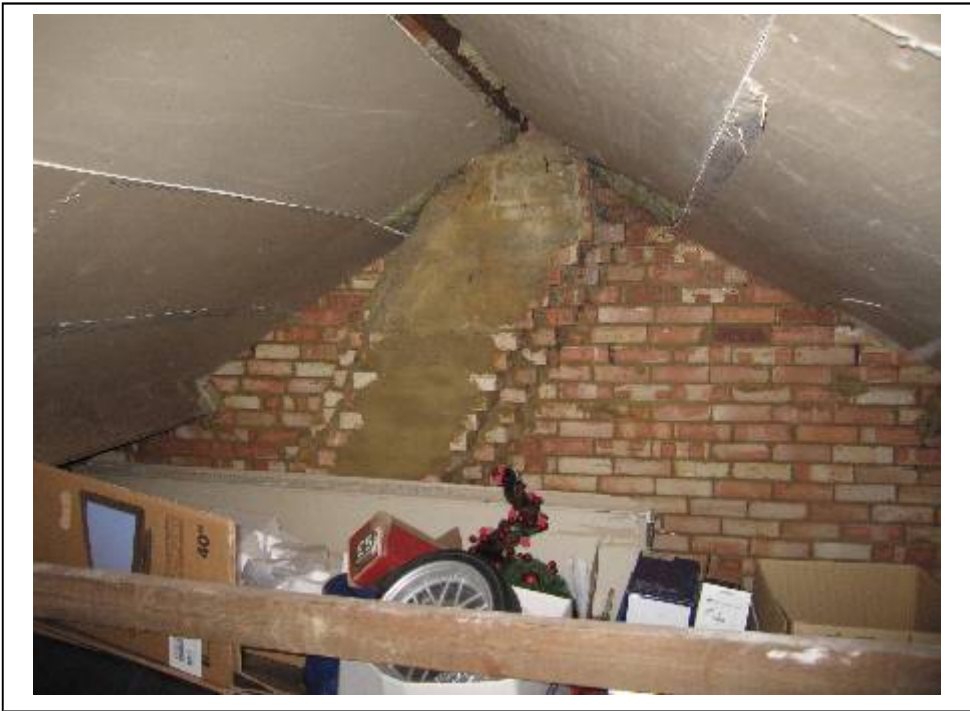
Roof void and party wall

E1. Roof structure	The large quantity of goods in the roof void prevented a complete internal inspection.	NI
E1. Roof structure Roof structure	The main roof is constructed using individual timbers in a traditional manner. The roof tiles are fixed over a lining of felt. Parts of the roof slopes are lined with plasterboard internally. The brick party wall was seen to be adequate to prevent the spread of fire between adjacent roof voids. The roof void is not provided with adequate ventilation, and there is a risk of condensation within the void. Some repairs or replacements are required but these are not considered serious or urgent.	2
